# Manhole Inspection Summary

Manhole # S450\_\_002MH

Insp Date: **6/6/08 11:13 AM**

**Location** Address: **1000 fell st**

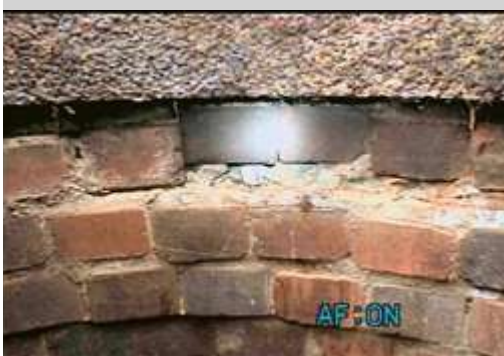
Defect 1

Condition: ☐ Sound ☐ Cracked ☐ Root Intrusion ☒ **Loose Brick** ☐ Deteriorated

loose bricks

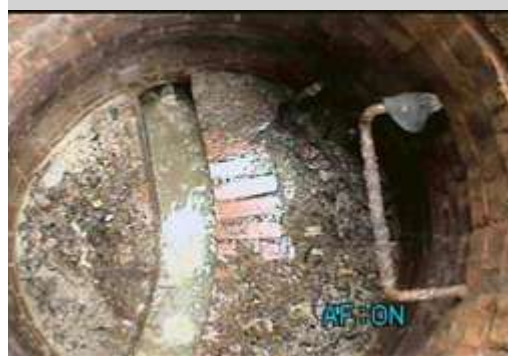
Defect 3

**Steps** Count: **2** Missing: **0** ☒ **Corroded**

steps

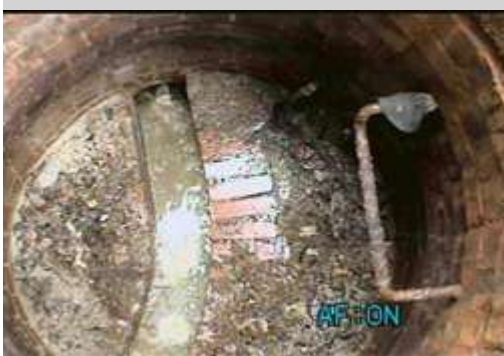
Defect 2

**Surcharge** ☒ **Evidence Of Surcharge** Depth: **4.1** (ft.) ☐ Active Surcharge Present

evidence of surcharge

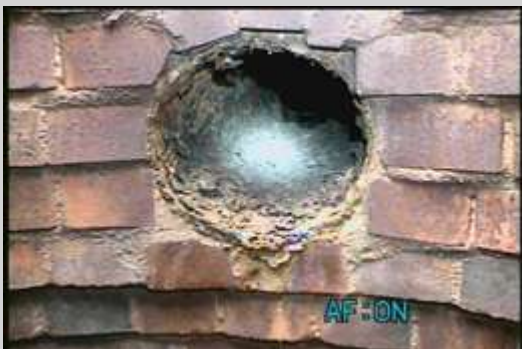
6 O'Clock Inflow

Deposits: ☐ None ☐ Mud ☐ Sludge ☒ Debris ☐ Grease

Silt Depth: 2 (in.) Deposits Extent: Medium

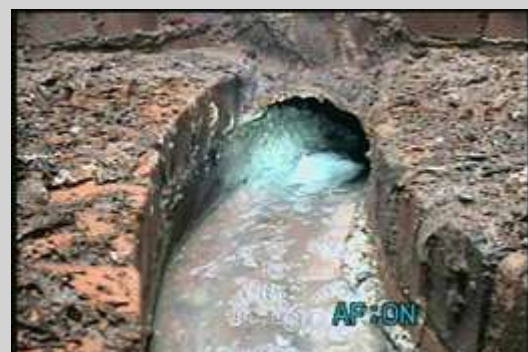
Drop In @ 6 OClock

Drop: Inside Direct  
Angled: Reading: 0.00 (ft.)  
Inv Depth: 5.63 (ft.)

Drop Condition: Partly Clogged
